ORNL-TM-627

REPORT ON FUEL-PLATE MELTING

AT THE OAK RIDGE RESEARCH REACTOR JULY 1, 1963

T. M. Sims
W. H. Tabor

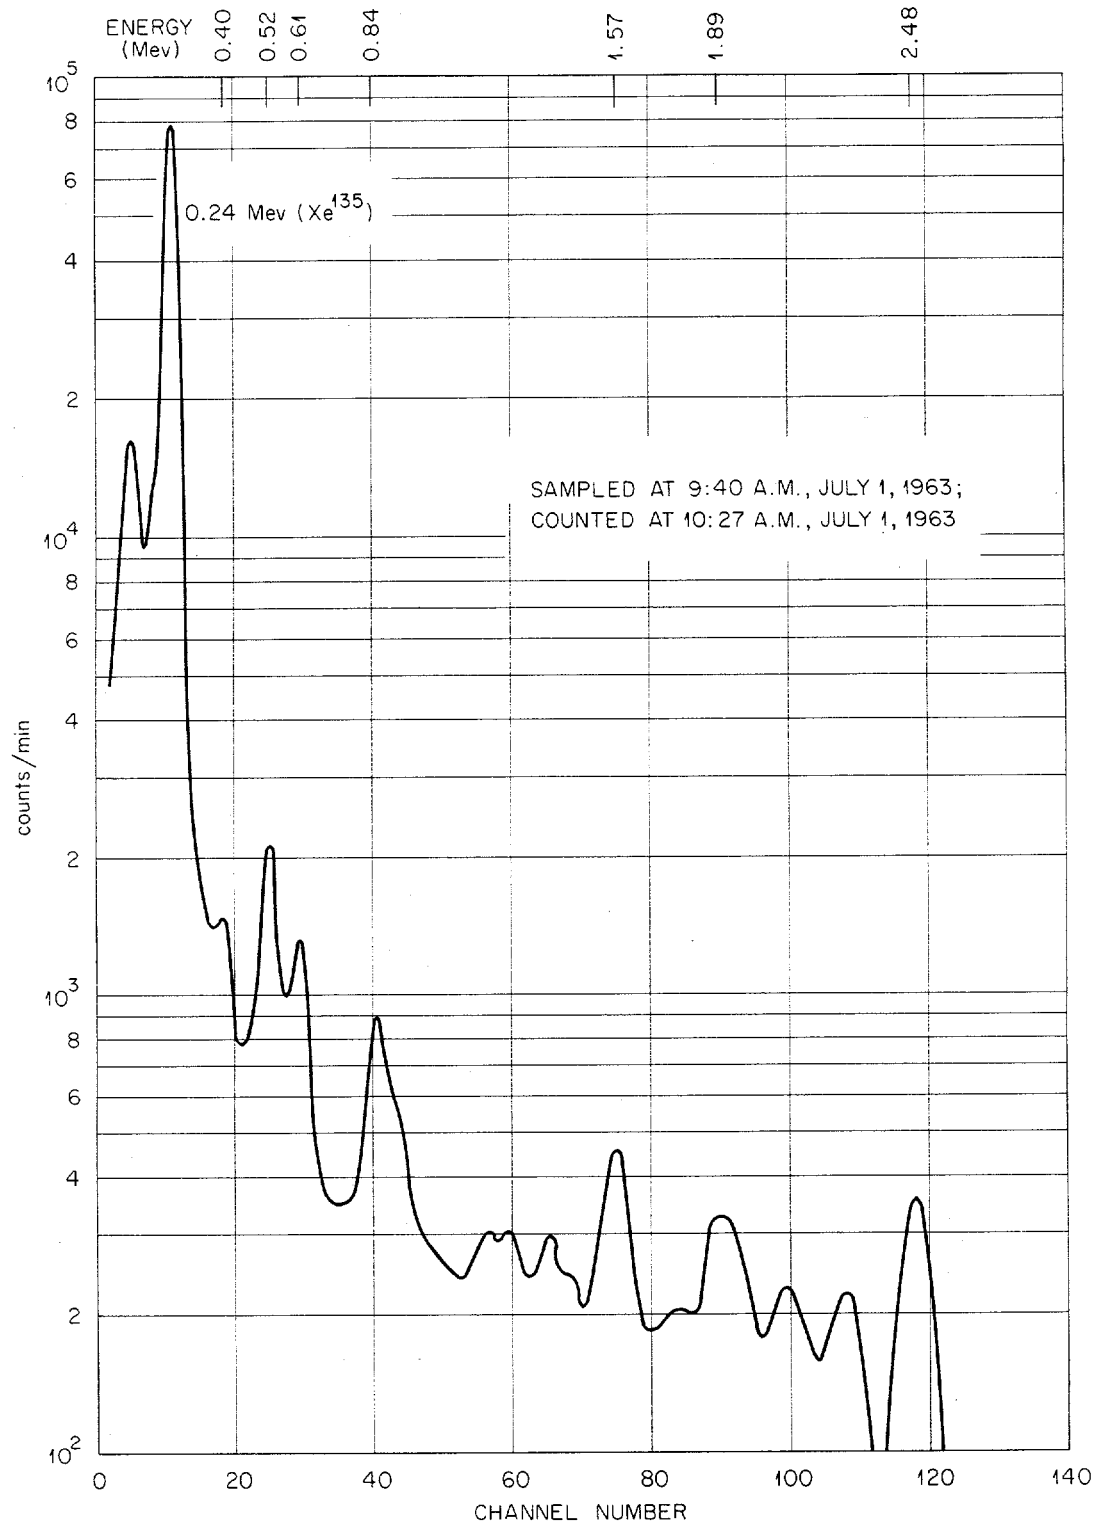
Fig. 9. γ -Spectrum of Gas from 500 cc of Reactor System Water

An analysis, on a gamma spectrometer, of the gases boiled from a 500-cc sample of the reactor system water taken at 9:40 AM (Figure 9) indicates the presence of ^{135}Xe in addition to ^{138}Xe and ^{88}Kr . The apparent preponderance of ^{135}Xe in this sample can probably be attributed to the fact that when the sample was taken most of the ^{88}Kr and ^{138}Xe had decayed.

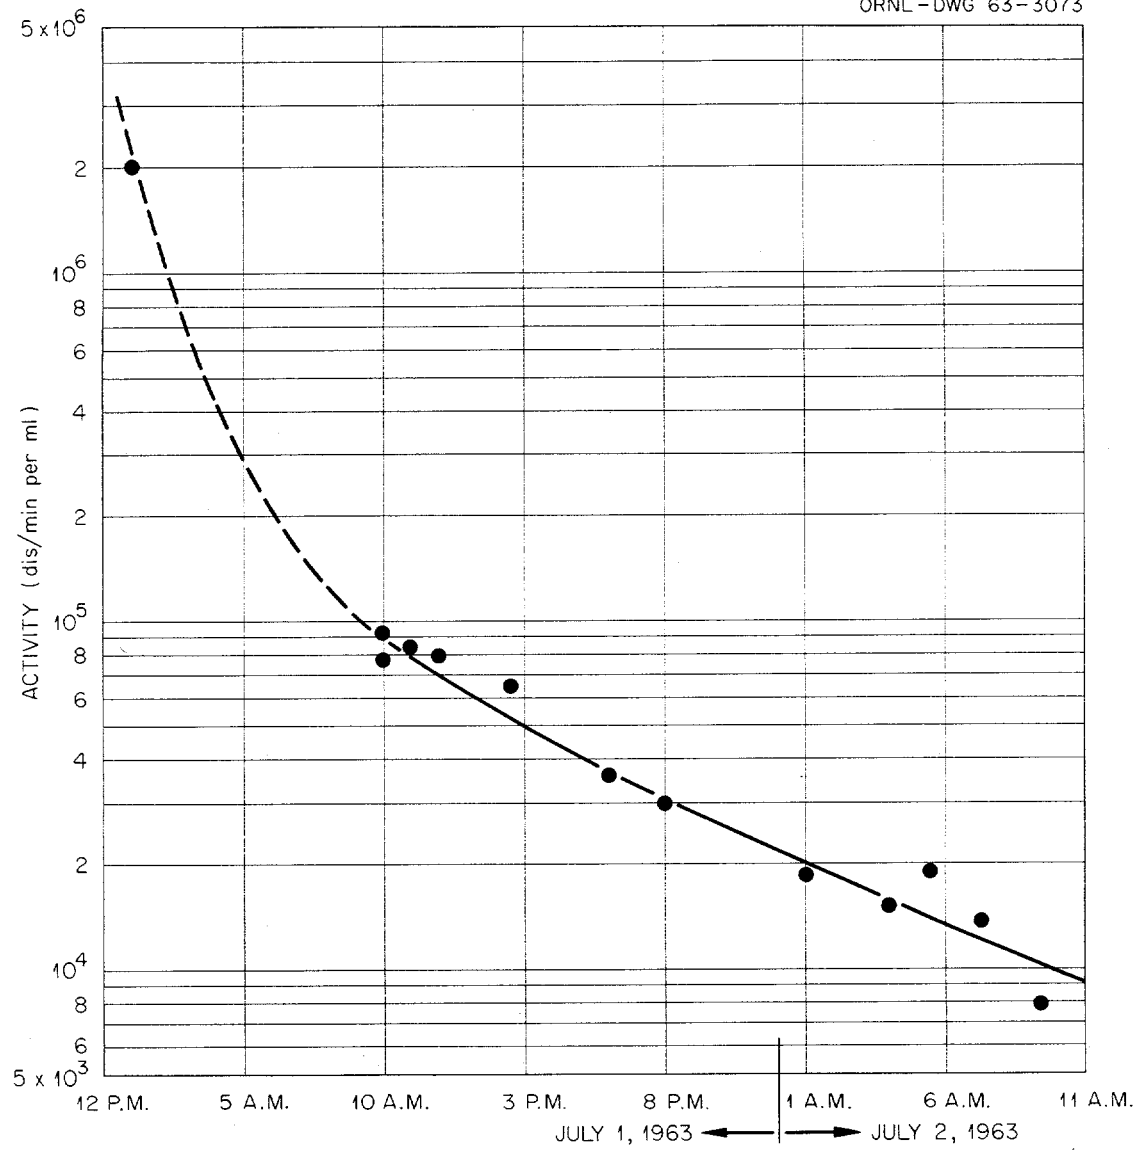
Fig. 10. Gross γ - β Activity Level; ORR Reactor Primary Coolant System

Figure 10 shows the decay of the gross β - γ contaminant concentration in the reactor water system as a function of time after the release. After four months, the gross gamma radioactivity level in the reactor primary system was about 70% greater than that prior to the incident. Presumably, this is due to small amounts of uranium released from the melted fuel which remain in, or near, the core in a region of high neutron flux. The major activities observed in the reactor water system are listed in Table 2. The radioactivities present in the system prior to July 1, 1963, are listed for comparison.

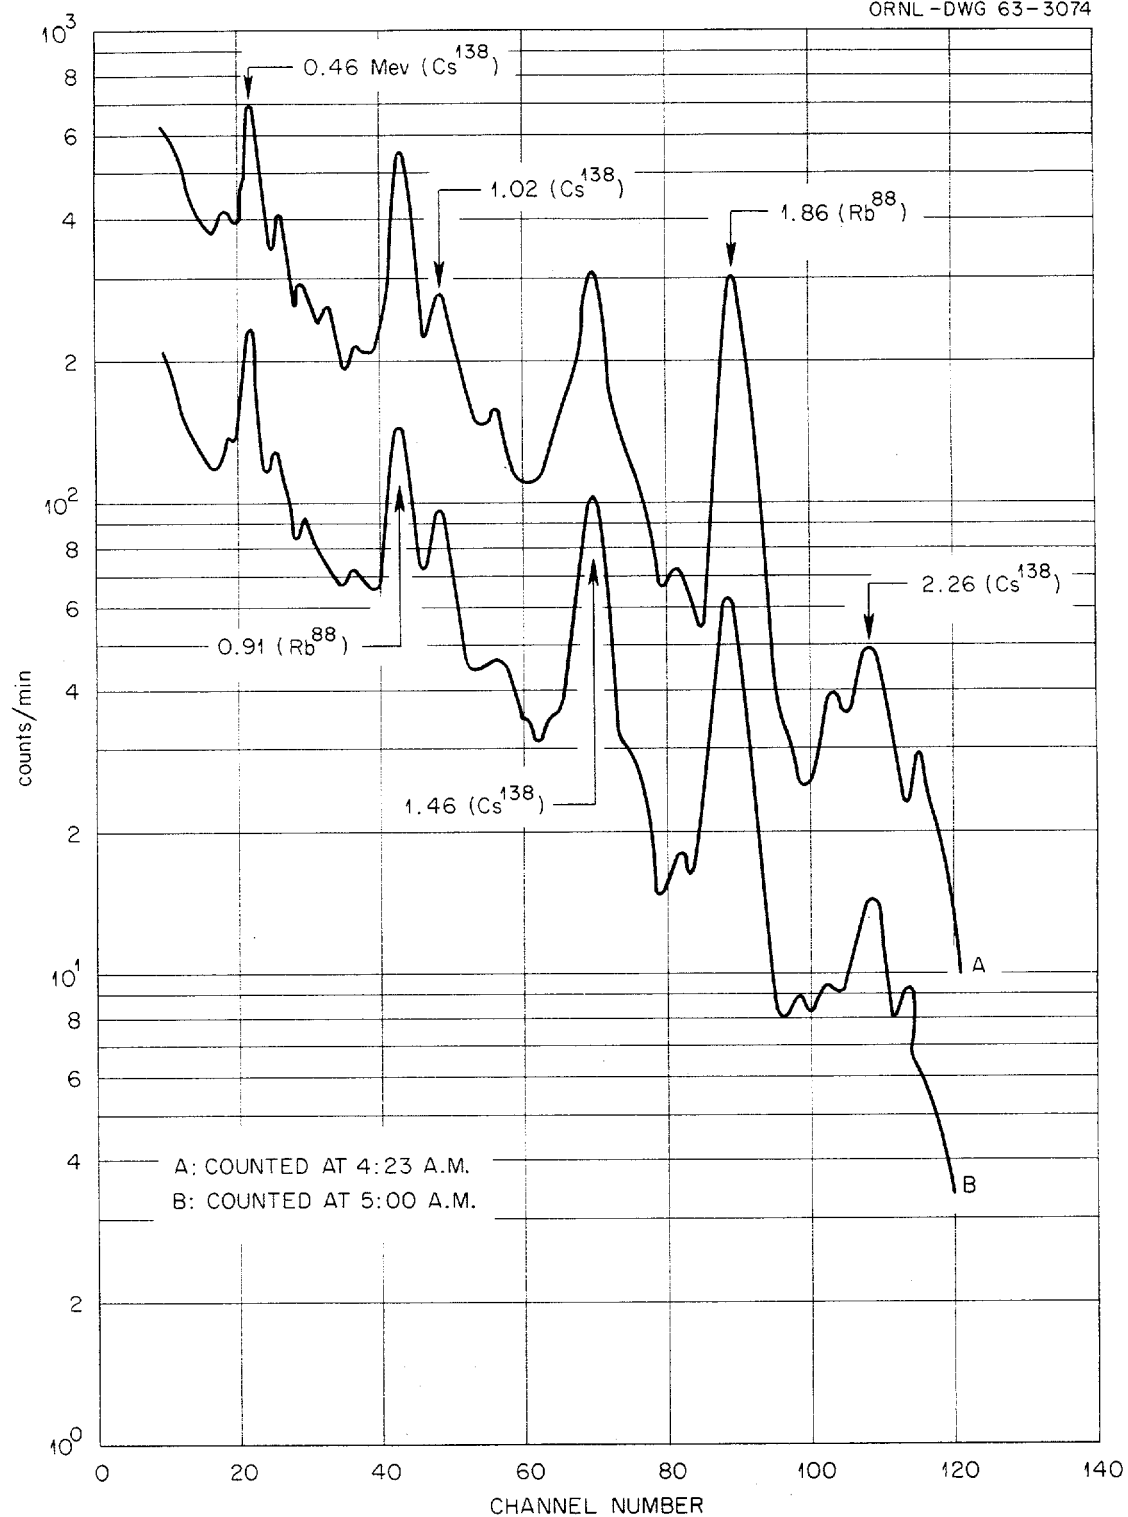
Fig. 11. γ -Spectra of Filter from Air Monitor

Some fraction of the noble gases released into the reactor coolant system diffused to the building atmosphere (principally as ^{138}Xe and ^{88}Kr) through the pool-reactor system equalizer to the pool and from the pool to the building atmosphere. Decay of these gases, subsequent to their release from the water system, resulted in air-borne contamination in the building primarily by ^{138}Cs and ^{88}Rb (identified by gamma-spectrometer analysis of the air monitor filter (Figure 11)). Peak air concentration of these contaminants is estimated at 10^{-6} to 10^{-7} $\mu\text{c/cc}$.¹ Estimates of the relative buildup of these isotopes in the building are given in Figure 12. The uncertainty in the levels indicated in the figure is due entirely to the uncertainty in the relative proportions of ^{138}Cs and ^{88}Rb present. Indicated upper limits are based on the assumption of 100% ^{88}Rb and indicated lower limits are based on the assumption of 100% ^{138}Cs .

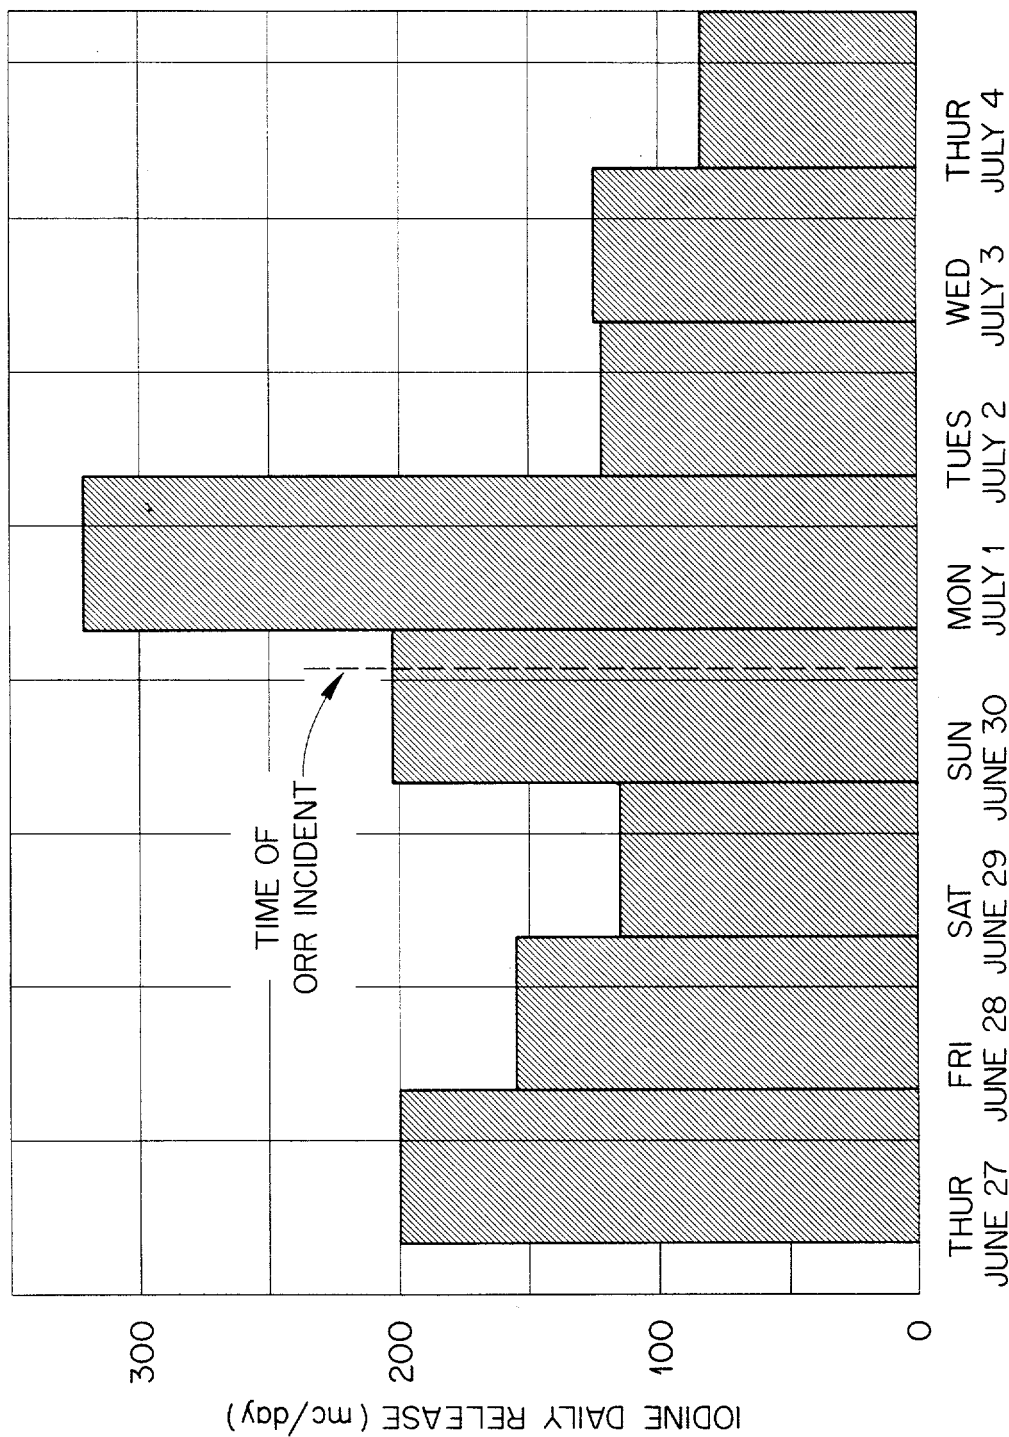
Fig. 13. Daily Iodine Release Through 3039 Stack

Figure 13 shows the amount of iodine released per day during the week surrounding the incident. The stack monitoring instruments indicated that approximately 150 mc of radioiodine were released through the stack as a result of the melting of the fuel plate. Most of the radioiodine released in the water system was undoubtedly removed by the demineralizers and by radioactive decay, although a small portion was probably removed by the caustic scrubber and filters in the off-gas system.

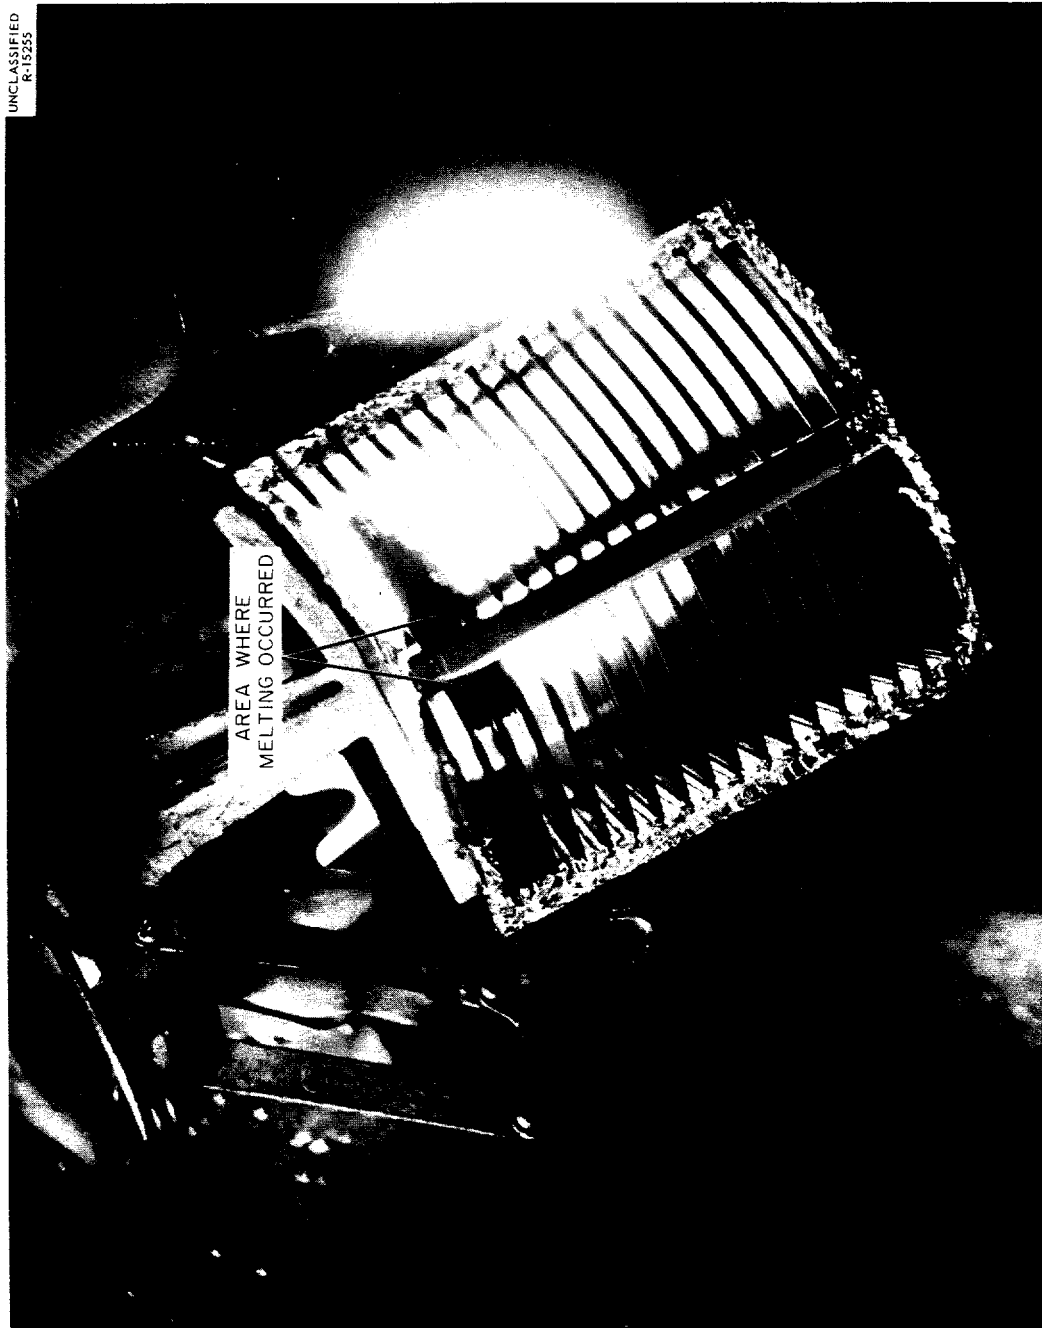
After the end-box sections were removed from the fueled section, visual inspections were made of the fueled section. Figure 18 is a photograph of the fuel plates taken from the bottom of the element. The darkened section between plates Nos. 2 and 3, and 3 and 4 (from the concave side) indicates the area where the melting occurred. Figure 19 views the fuel plates from the top. The "foreign" particles, with one exception, are cuttings from the disassembly of the end box. The dark material between plates Nos. 1 and 2, on the concave side, is a portion of the gasket material which adhered to the plates.

Fig. 18. Bottom View of Fuel Plates of ORR Element OR-36C

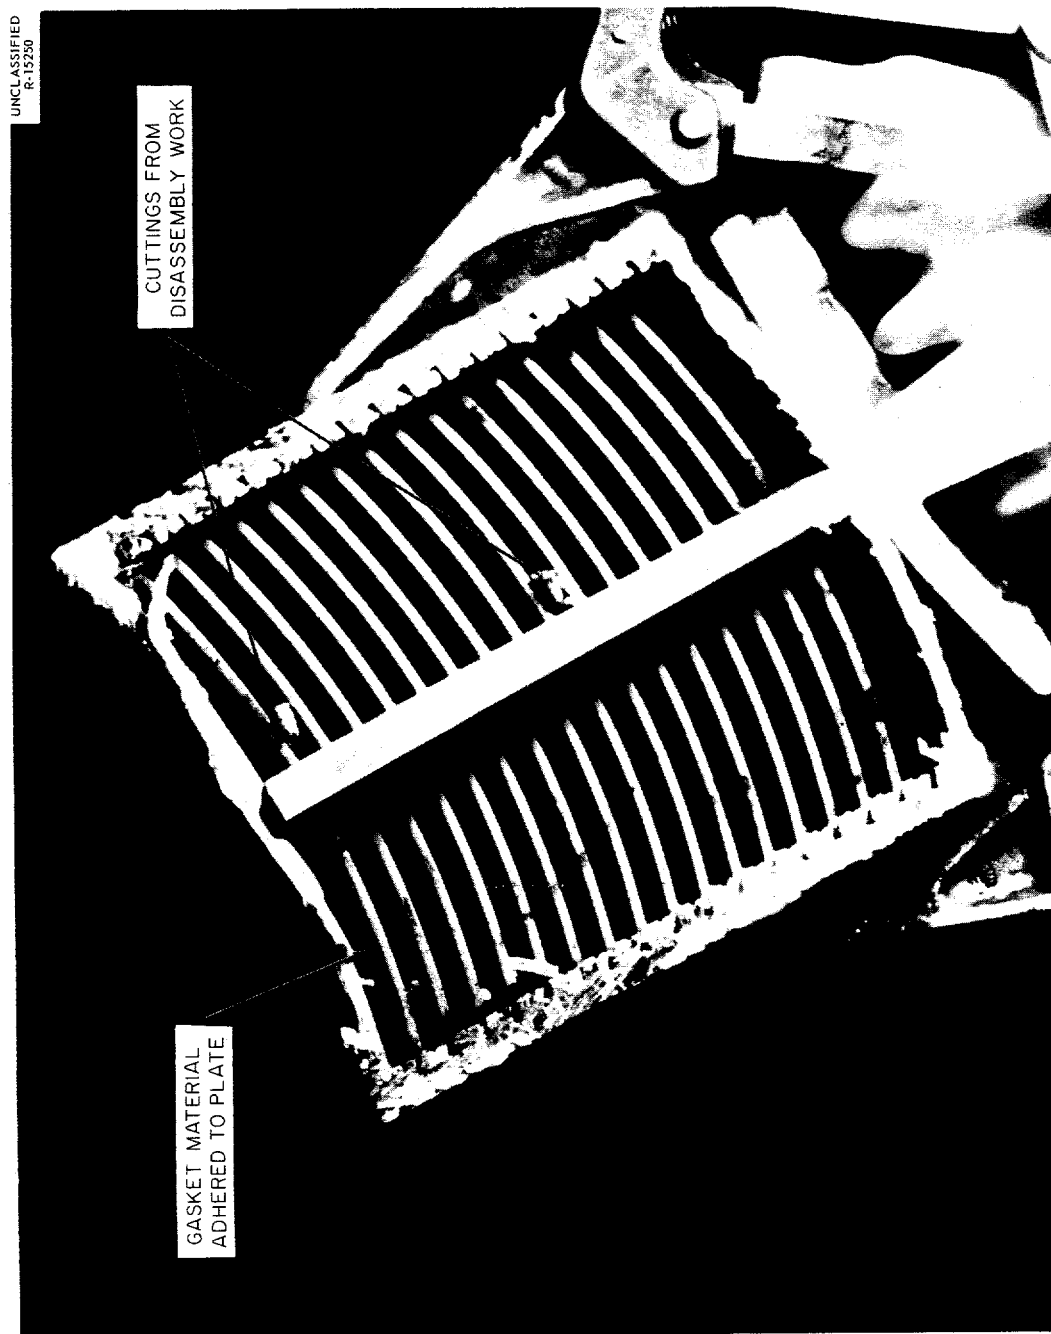
Fig. 19. Top View of Fuel Plates of ORR Element OR-36C

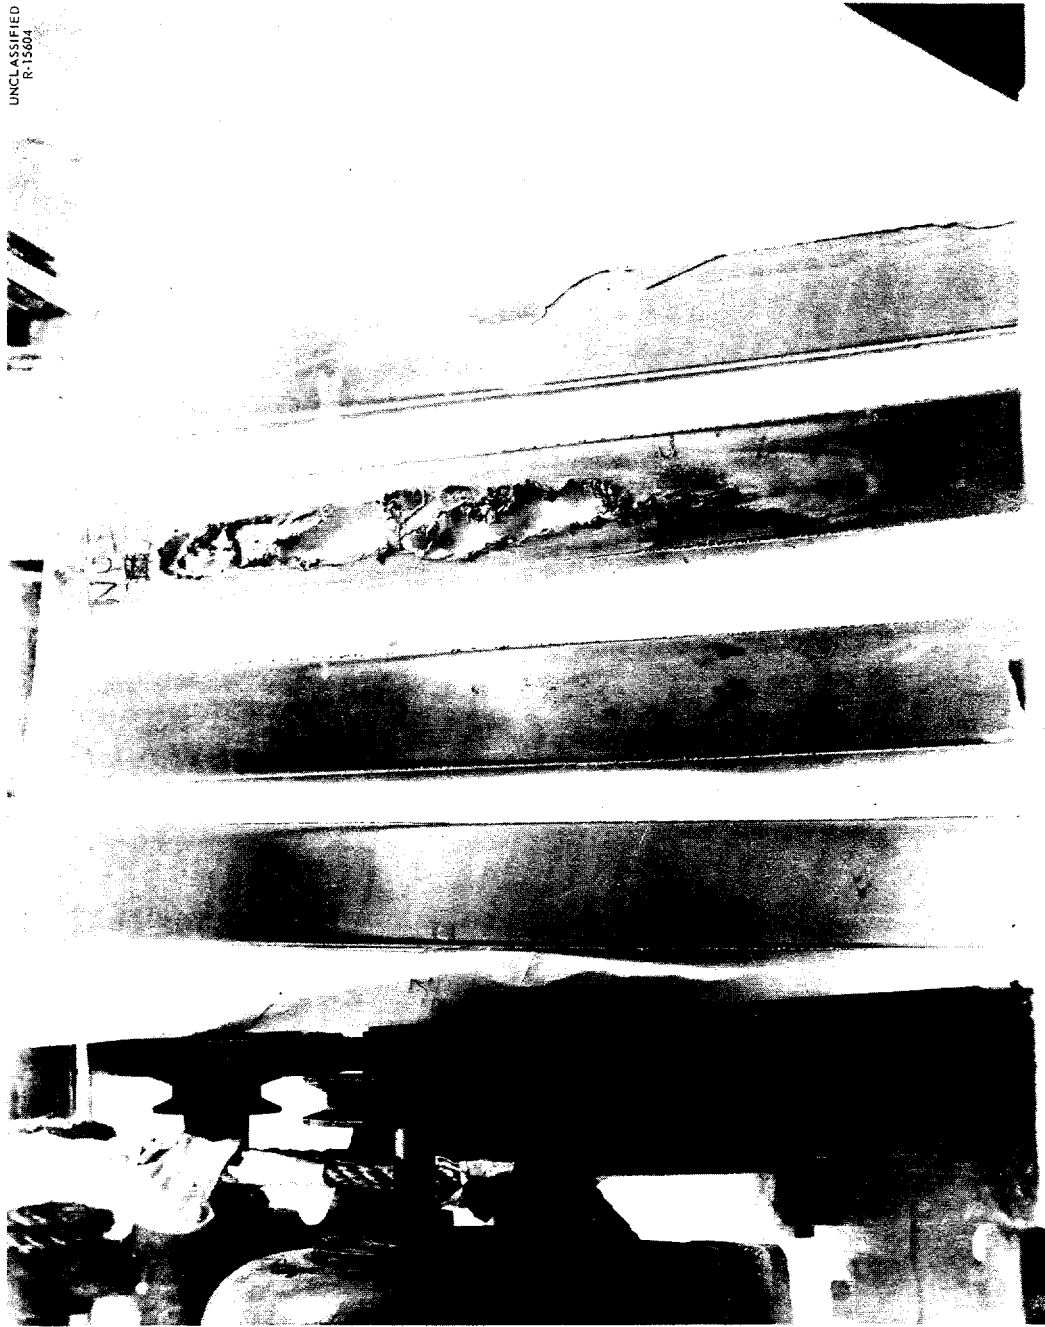
The fueled section of the element was transferred to a segmenting cell where the plates were removed. Each plate was visually inspected. Figures 20 and 21 show the plates after they were separated from the assembly. The melting occurred in the top section (as oriented in the reactor) of the plate. Visual inspections of the adjacent plates, as well as other plates in the element, did not indicate any surface damage although there was some discoloration.

Fig. 20. Convex Side of Plates from ORR Element OR-36C

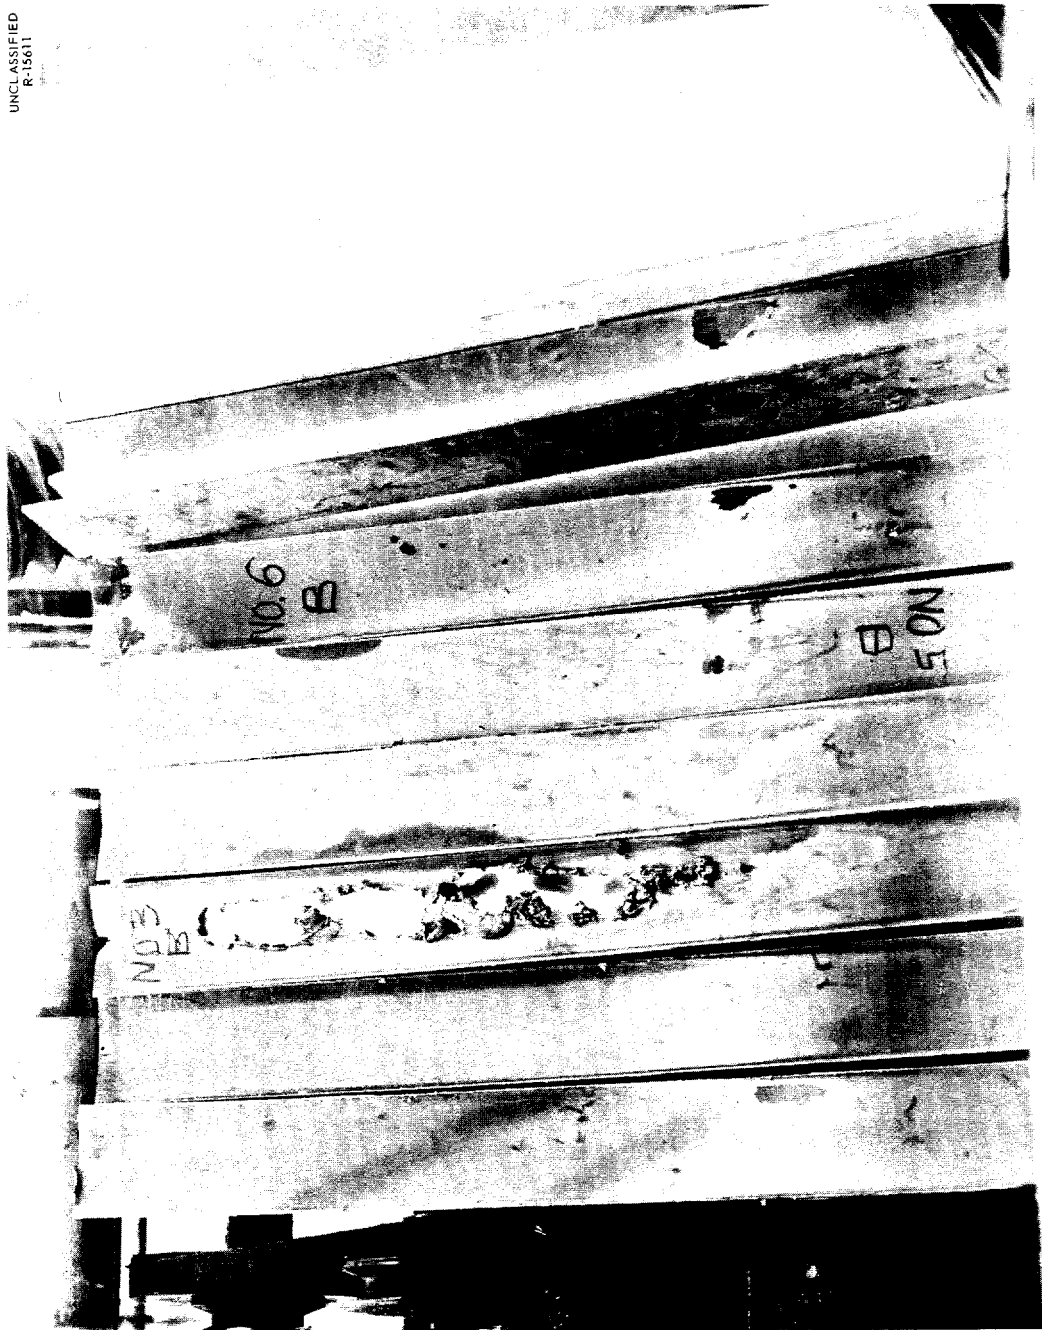
Fig. 21. Concave Side of Plates from ORR Element OR-36C
